Exhibit D**U.S. Department of Labor****Occupational Safety and Health
Salt Lake Technical Center
Sandy, Utah 84070**

**Report Date:** 10 July 2019**Establishment:** Southern Skills Trades and Detyen's Shipyards, Inc.**Inspection Number:** 1391255, 1391322**Compliance Officer:** [REDACTED]**Area Office:** Columbia**Region:** 4**SLTC Investigator:** Daniel T. Crane**Evaluation of wire rope used for securing a davit on a ship during repair**

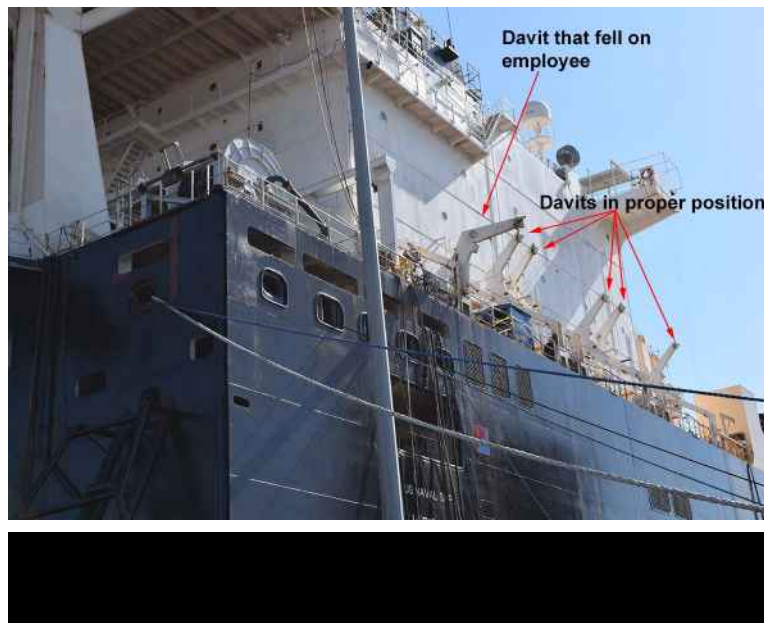
Figure 1 shows the position of the davits on the ship. Note that one of the davits is lowered. The wire rope that secured it failed and allowed it to fall, striking an employee who was working underneath it.

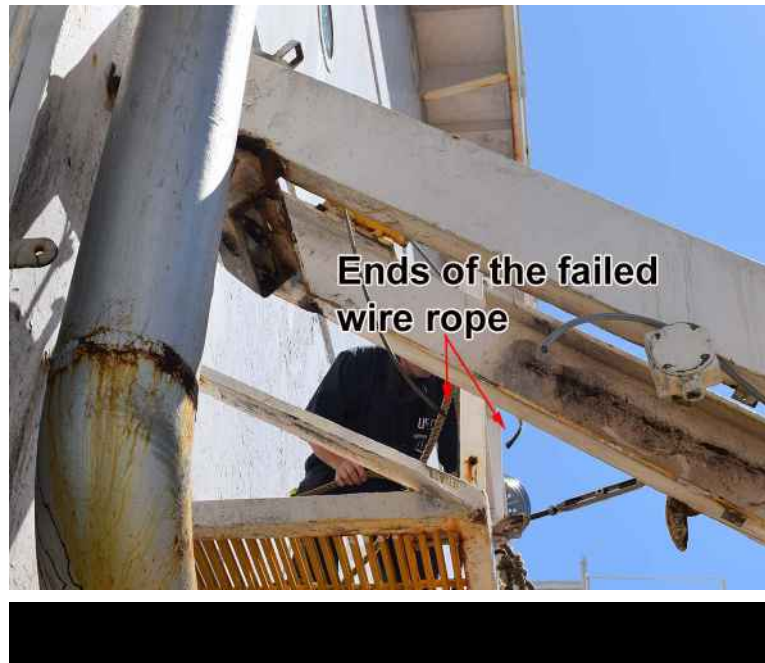
Figure 4 shows the location of the ends of the failed wire rope before it was removed from the ship.

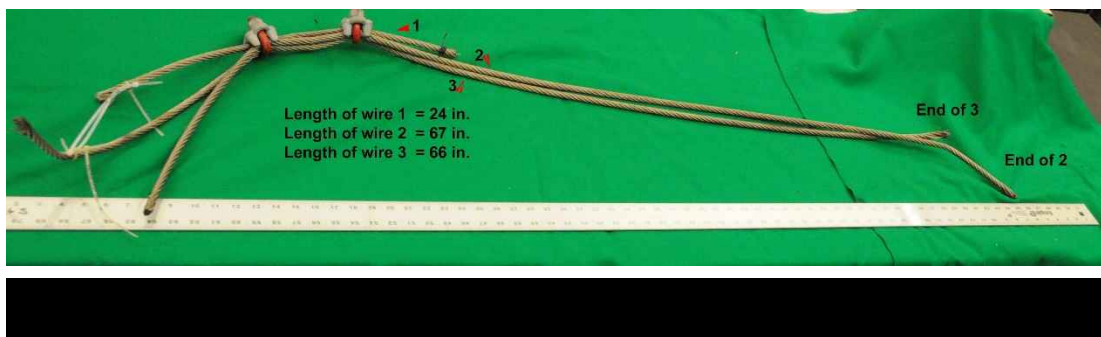
In use, the wire rope was secured with two wire rope clips. Figure 5 shows the wire rope sample with the wire ropes in place, as submitted with the lengths of each segment noted.

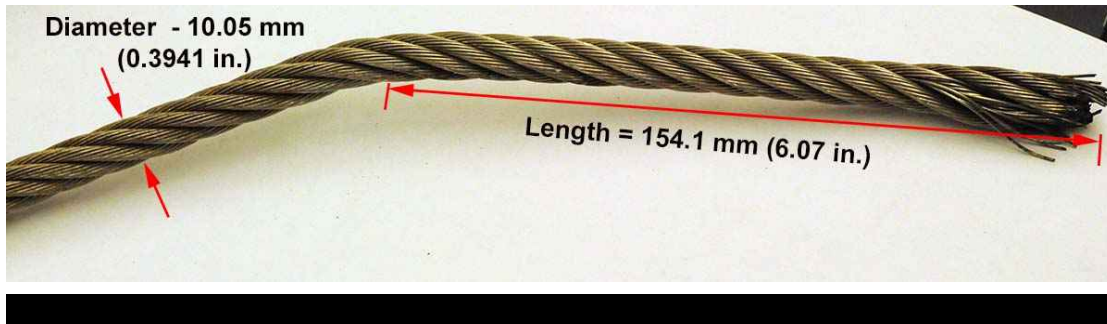
Segment 2 has a sharp bend at about 6 in. from the failed end. The bend is likely a result of the wire rope rigged around a sharp corner of an element of the davit without relief or protection. Figure 6 shows this bend and that the diameter of the wire rope was measured to be 10.01 mm (0.3941 in.). For reference, a 3/8 in. diameter wire rope is nominally 0.375 in.

The wire rope segments submitted for evaluation were originally a single length of 10 mm diameter 7x19 stainless steel rope used to secure a davit arm. The wire rope was in tension at the time of the failure, holding the davit arm in position. It failed and was subsequently cut from the structure in order to be sent to SLTC. This resulted in 3 distinct segments clipped together with two wire rope clips. The wire rope had been wrapped around a member of the davit which had sharp corners. The rope was not protected from the sharp corners and this resulted in at least 1 residual bend.

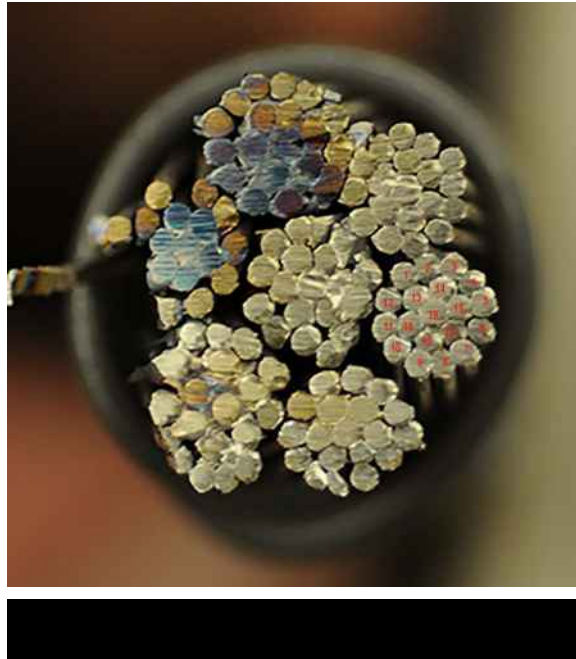
Figure 7 is an end-view of the wire rope. It may be classified as 7x19 construction by this pattern. The wire rope is stainless steel with Cr and Ni.

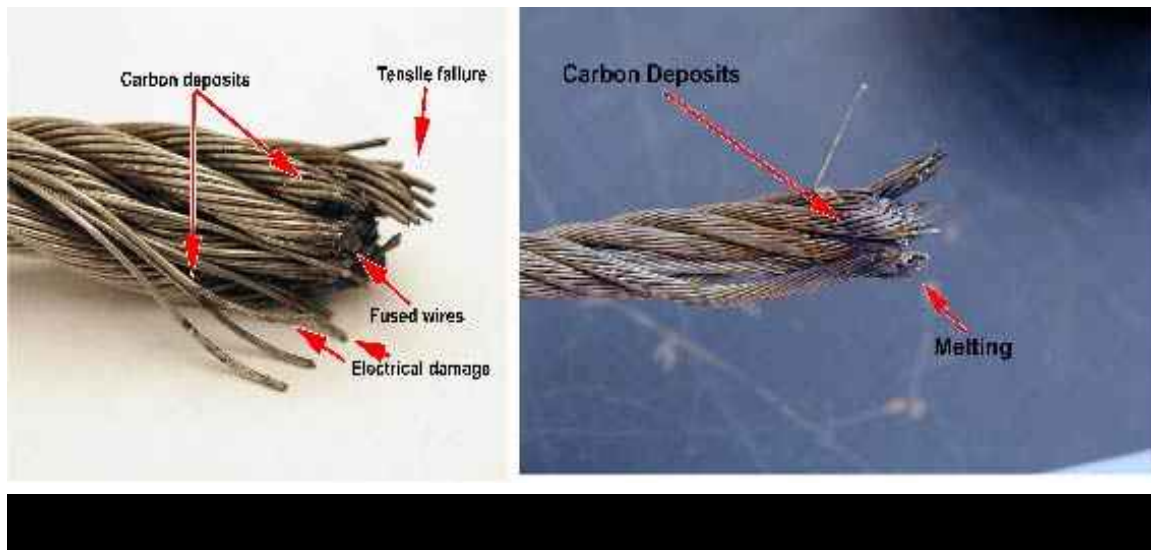
Figure 8 shows the two failed ends. All of the strands and wires have failed at about the same location. A few of the wires failed in tension, demonstrated by necking and shear failure. Most of the damage at the ends is characterized by fusing. The presence of carbon deposits as shown in Figure 8 are evidence that the failure was a result of an electrical event.

There was no evidence found of a strike by a welding rod. The wire rope failed due to an electrical arc.

Such arcs are caused by a voltage potential difference between the wire rope and the superstructure to which it is attached.

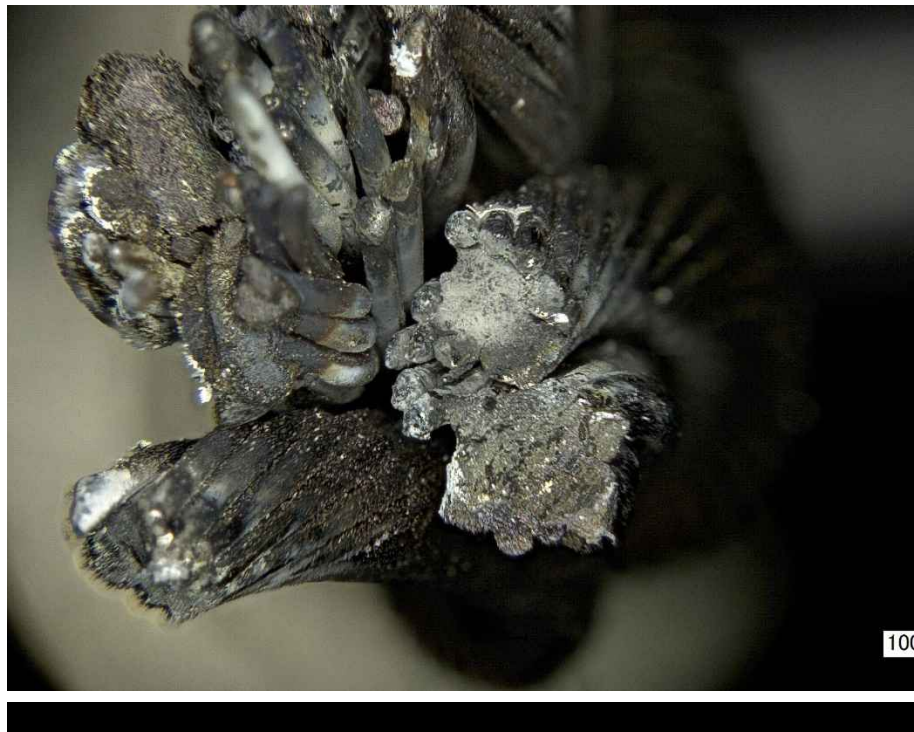
Figure 9 is an image generated using the Keyence VHS1000 showing how the individual wires of the strands were fused together in the incident.

There was no obvious evidence of a welding strike on either failed end.
